## **Hazard Summary**

Risk of rupture on pressure vessels due to corrosion

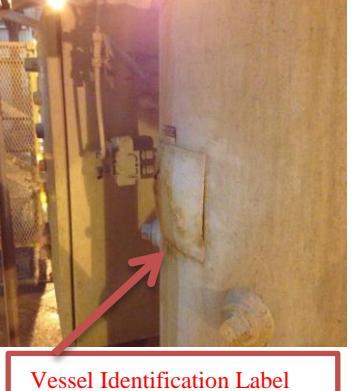
On February 4, 2015, the Regional Boiler/Gas Inspector of the Government of the Northwest Territories (GNWT) conducted an annual inspection of pressure vessels at a mine process plant. The inspection revealed signs of corrosion between metal identification tags and the pressure vessel walls on a number of air receivers.

Further testing confirmed that the pressure vessel's walls were thinner in localized areas on three of the air receivers. To minimize the risk of a rupture, the Inspector requested that the air supply system be shut down. A 30 metre personnel exclusion zone was created to keep workers out of the area during repair.

shows deformation due to corrosion

- Conduct regular visual inspections of pressure vessels;
- Be aware of signs of physical damage or degradation to the pressure vessel;
- Remove suspect vessels from operation; and
- Verify unusual observations with non-destructive or ultrasonic thickness testing.

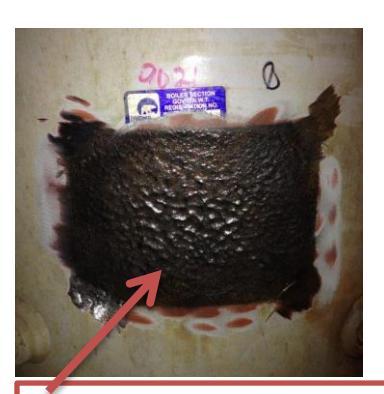
Area of corrosion becomes visible once Vessel Identification Label is removed for non-destructive testing (NDT)
